# UNDERWATER BRIDGE INSPECTION REPORT

STRUCTURE NO. 03503

CHANNEL BETWEEN DETROIT LAKE AND DEAD SHOT BAY

MINNESOTA DEPARTMENT OF TRANSPORTATION  
UNDERWATER BRIDGE INSPECTION

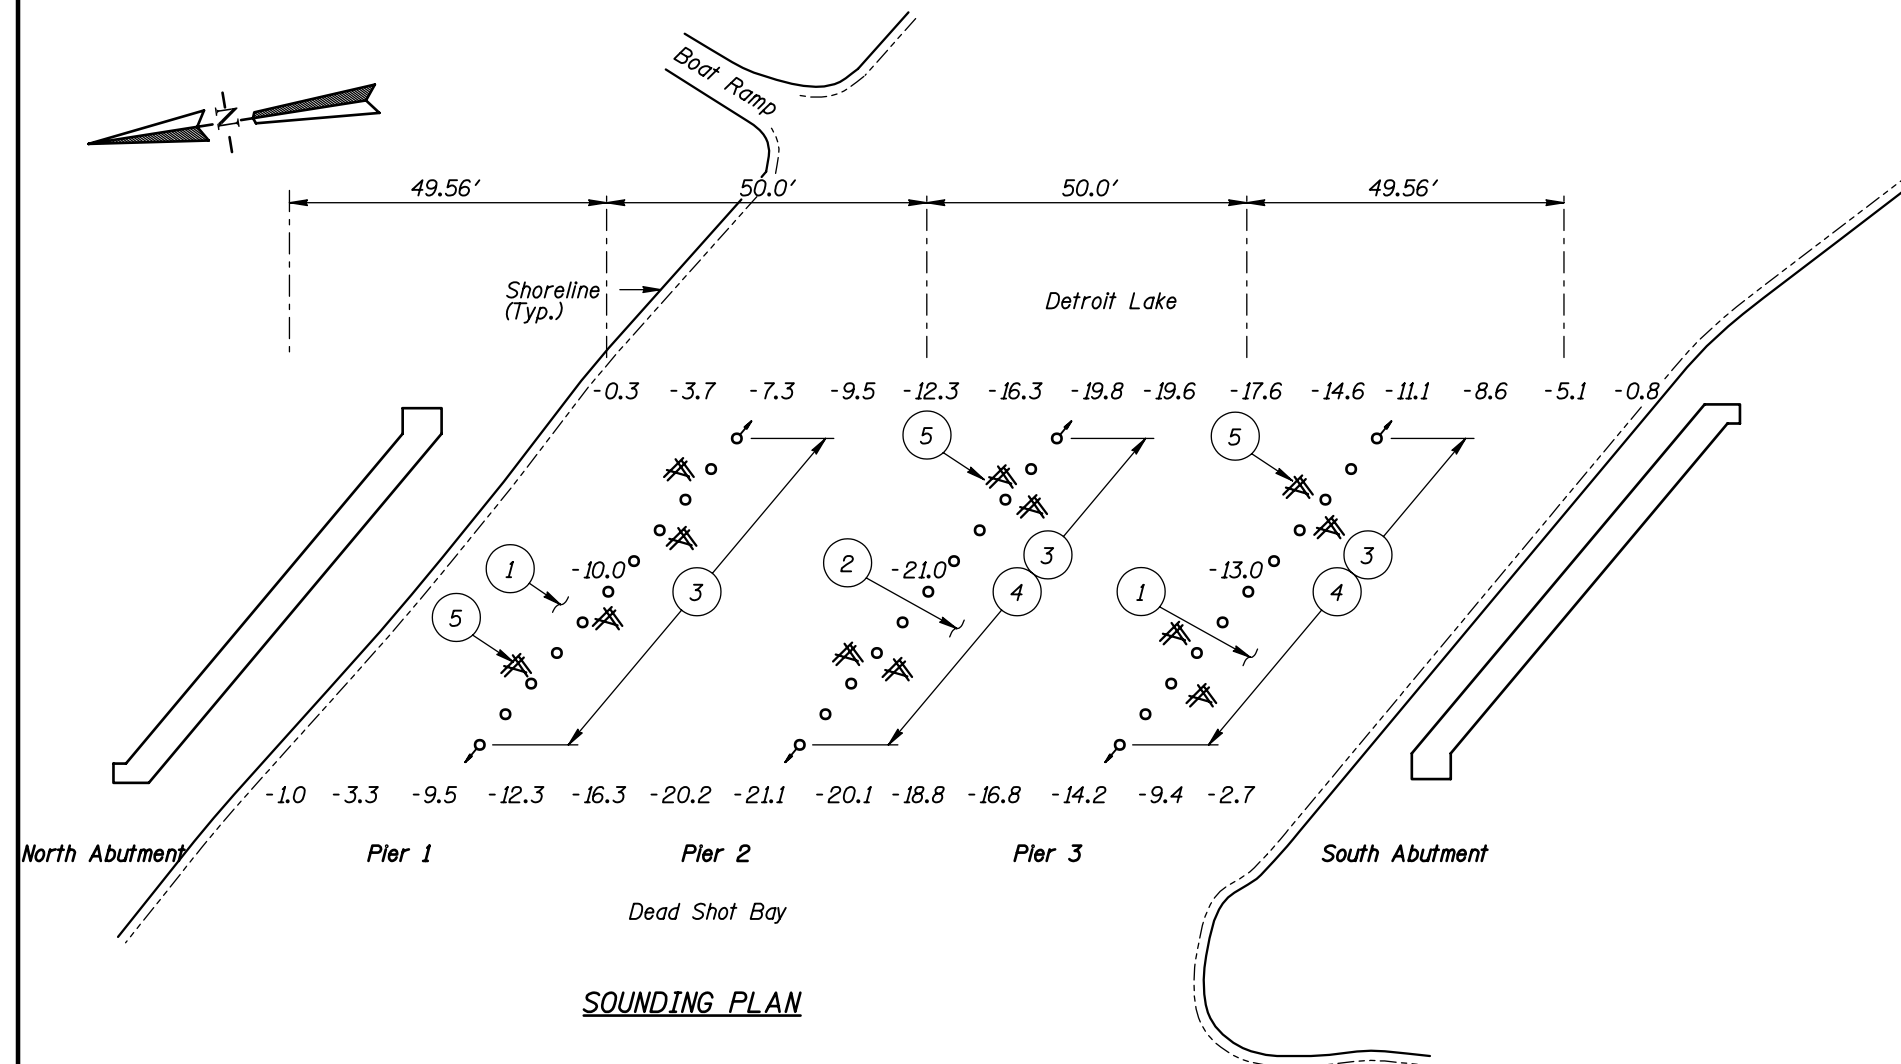
**INSPECTION AND SOUNDING PLAN**

- 1 The channel bottom consisted of 6 inch diameter cobbles and sandy silt with up to 1 foot of probe rod penetration.
- 2 The channel bottom consisted of sand with up to 6 inches of probe rod penetration.
- 3 The steel pipe piles exhibited coating failure with light surface corrosion from 1.5 feet above the waterline to the channel bottom.
- 4 The steel pipe piles exhibited rust nodules, typically 1/8 inch in diameter and up to 1/4 inch in diameter, over 30 percent of the surface area from 10 feet below the waterline to the channel bottom.
- 5 Timber debris, consisting of logs up to 12 inches in diameter, was scattered throughout the piles of all the piers.

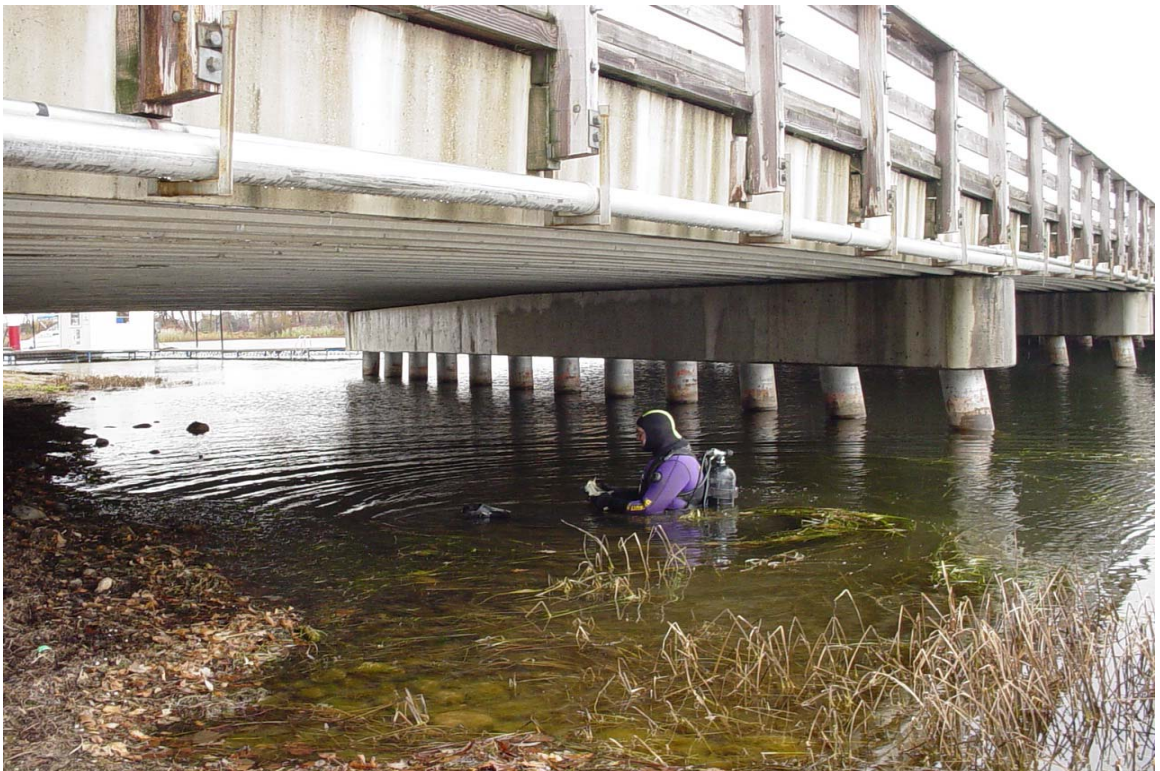
Photograph 2. View of Pier 1, Looking Southeast.

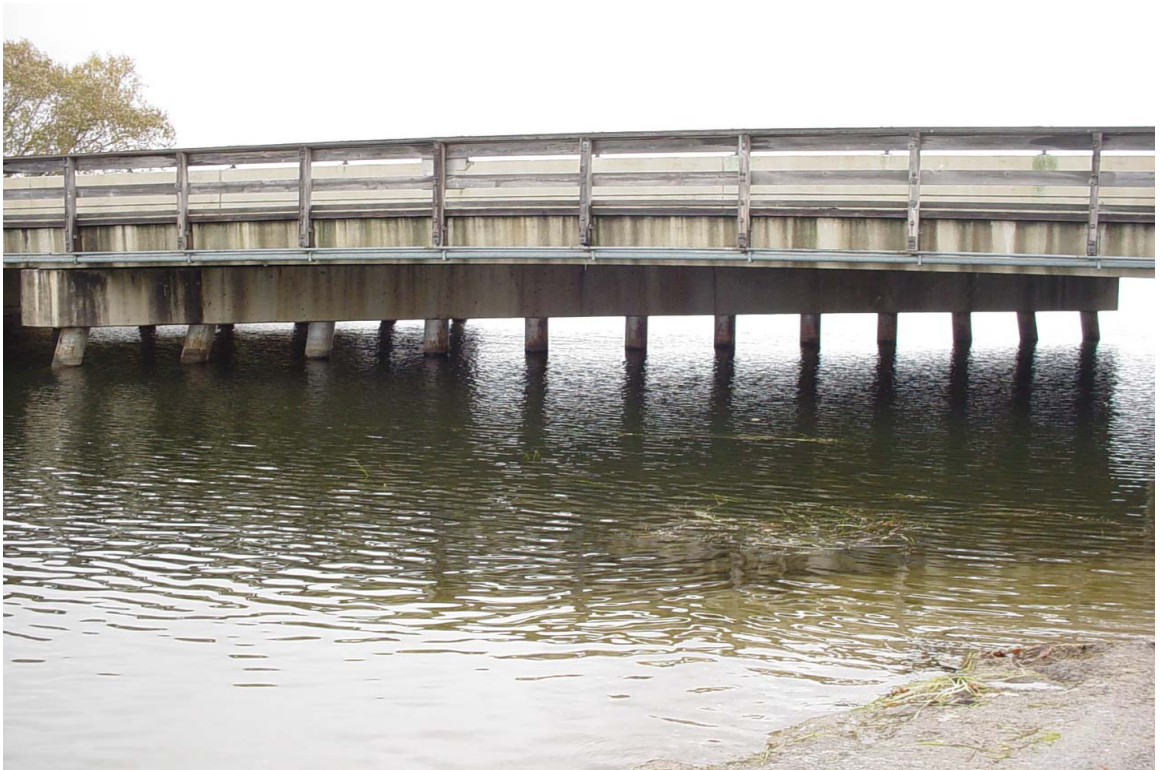
Photograph 4. View of Pier 2, Looking Southwest.

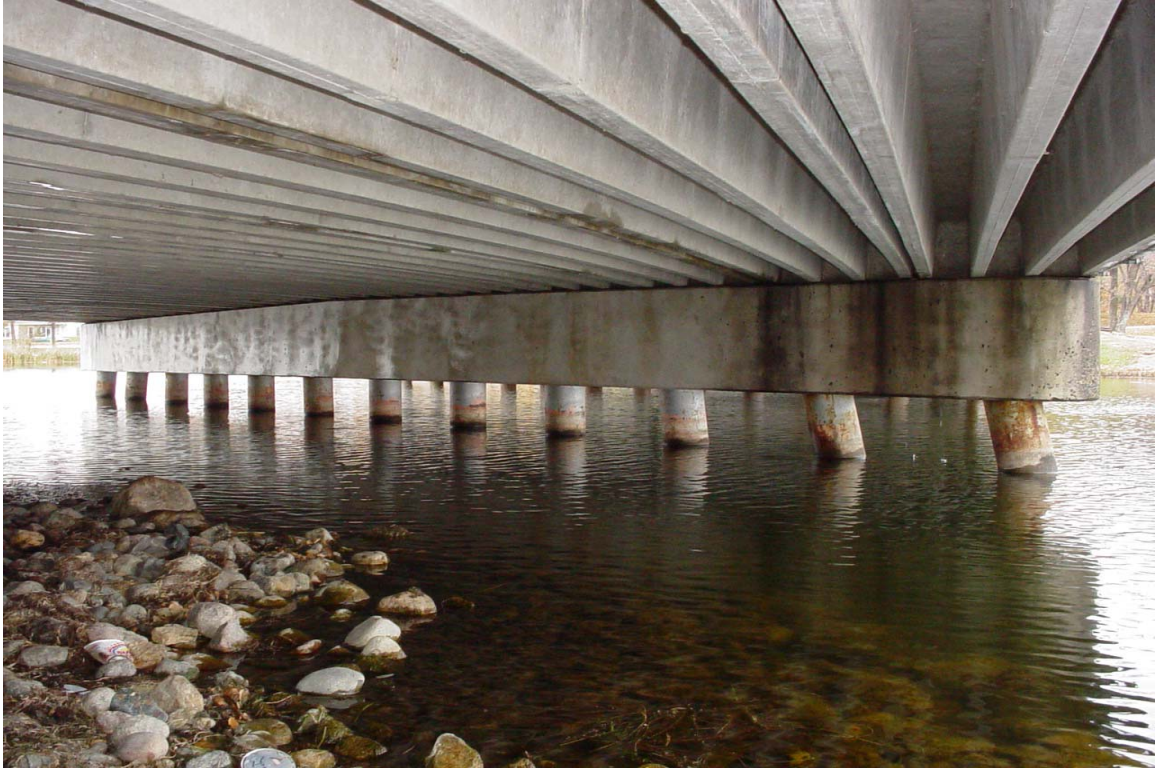
Photograph 5. View of Pier 3, Looking North.

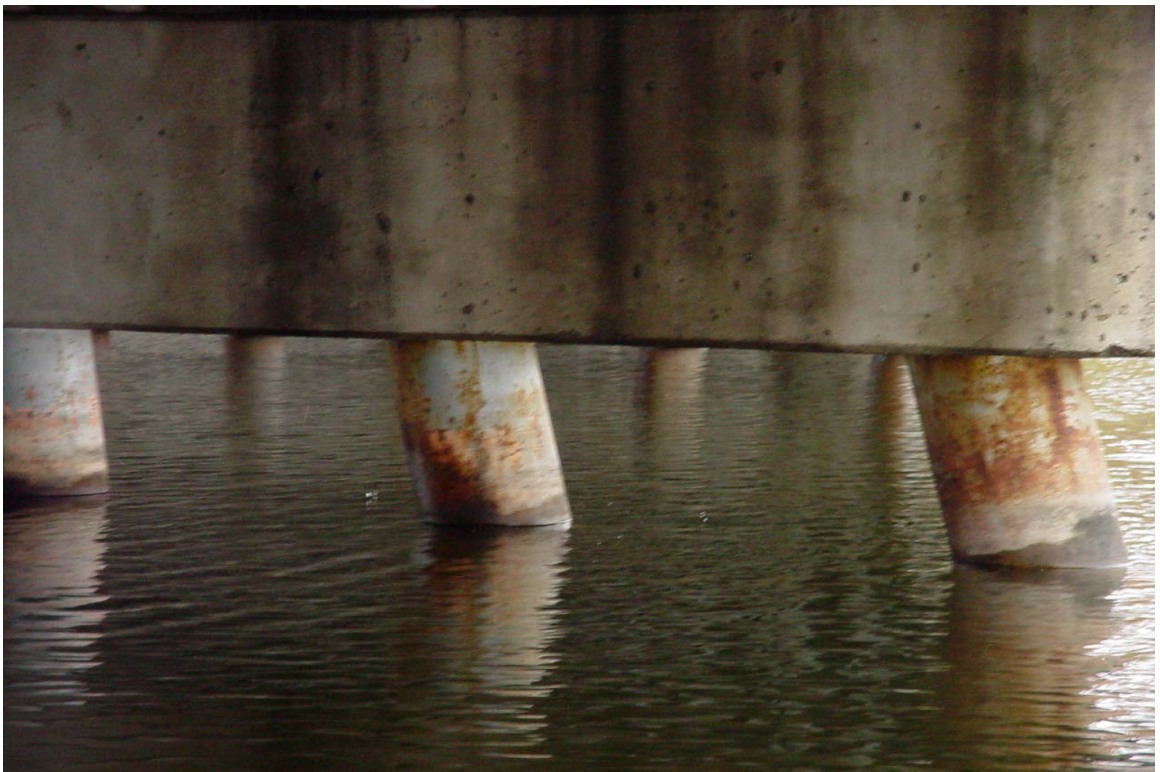
- (A) The protective coating on the cast-in-place steel pipe piles on all piers exhibited signs of initial breakdown from 1.5 feet above the waterline to the channel bottom.
- (B) Random rust nodules, 1/8 inch to 1/4 inch in diameter, were observed covering over 30 percent of the surface area of the piles at Piers 2 and 3 from 10 feet below the waterline to the channel bottom.
- (C) Timber debris, up to 12 inches in diameter, was observed scattered throughout the channel bottom at all piers.

Photograph 6. Typical Coating Failure on the Steel Pipe Piles.
